Subject: Chrysler Group, LLC Failure-to-Warn/Comply under 49 CFR § 573.6, et al.

Reference 1: Toyota Motor Corporation/NHTSA Recall 12V-305
Reference 2: EA12-005 File Update (Chrysler Jeep Fuel Tank System Safety Defect)

Chrysler Jeep Fuel System Defect Investigation EA12-005

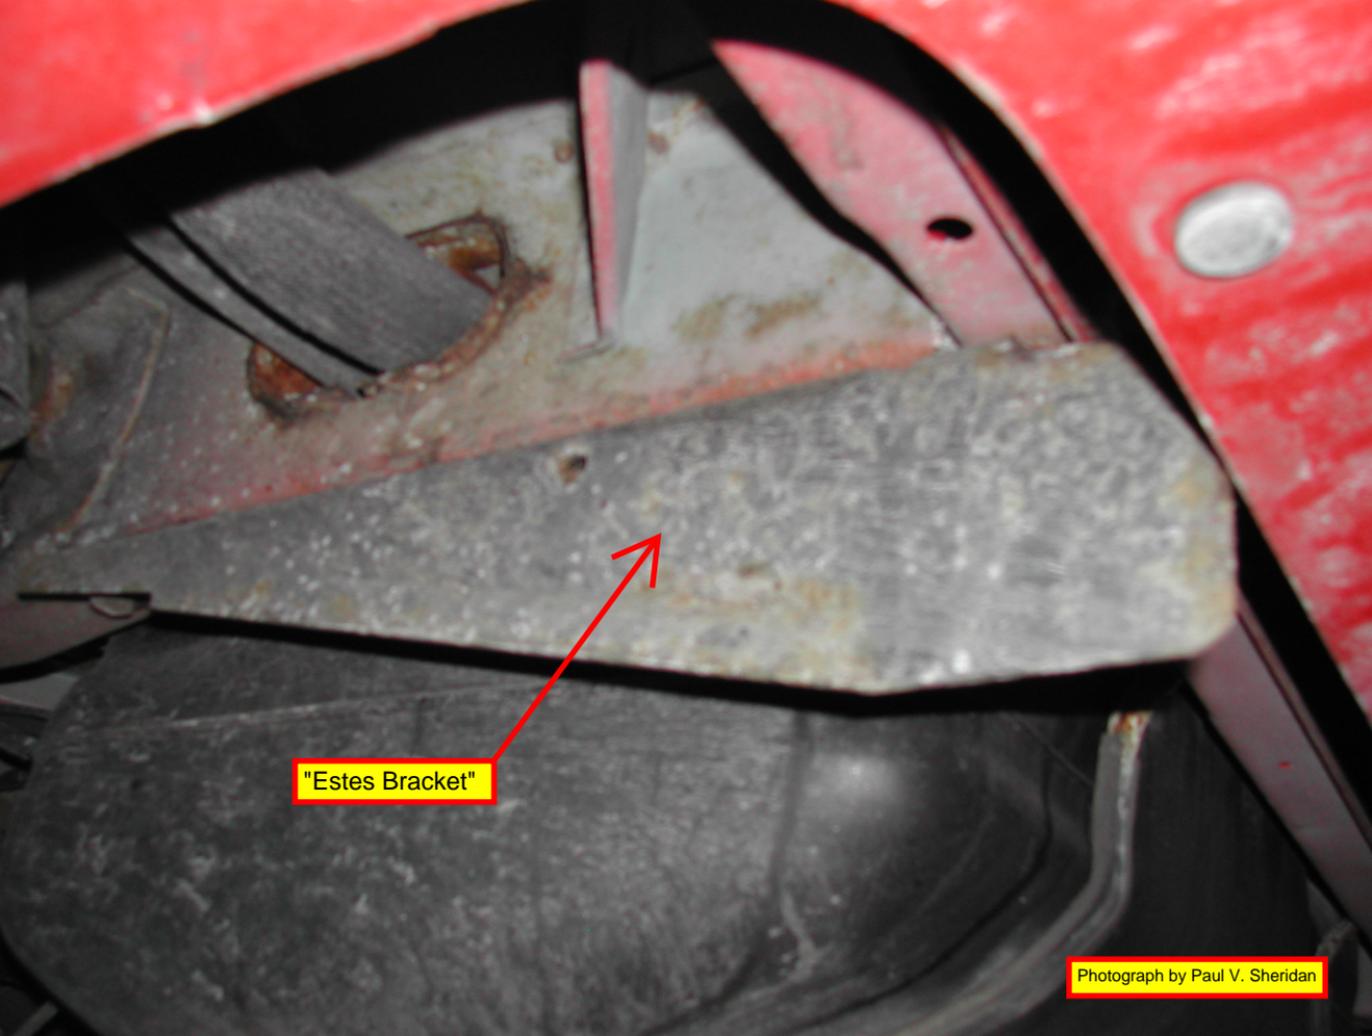
"Estes Bracket"

Photographs of last-minute release of preposterous, make-shift reinforcement to the rear frame rail, nicknamed the “Estes bracket” for the 1997 Jeep Grand Cherokee.

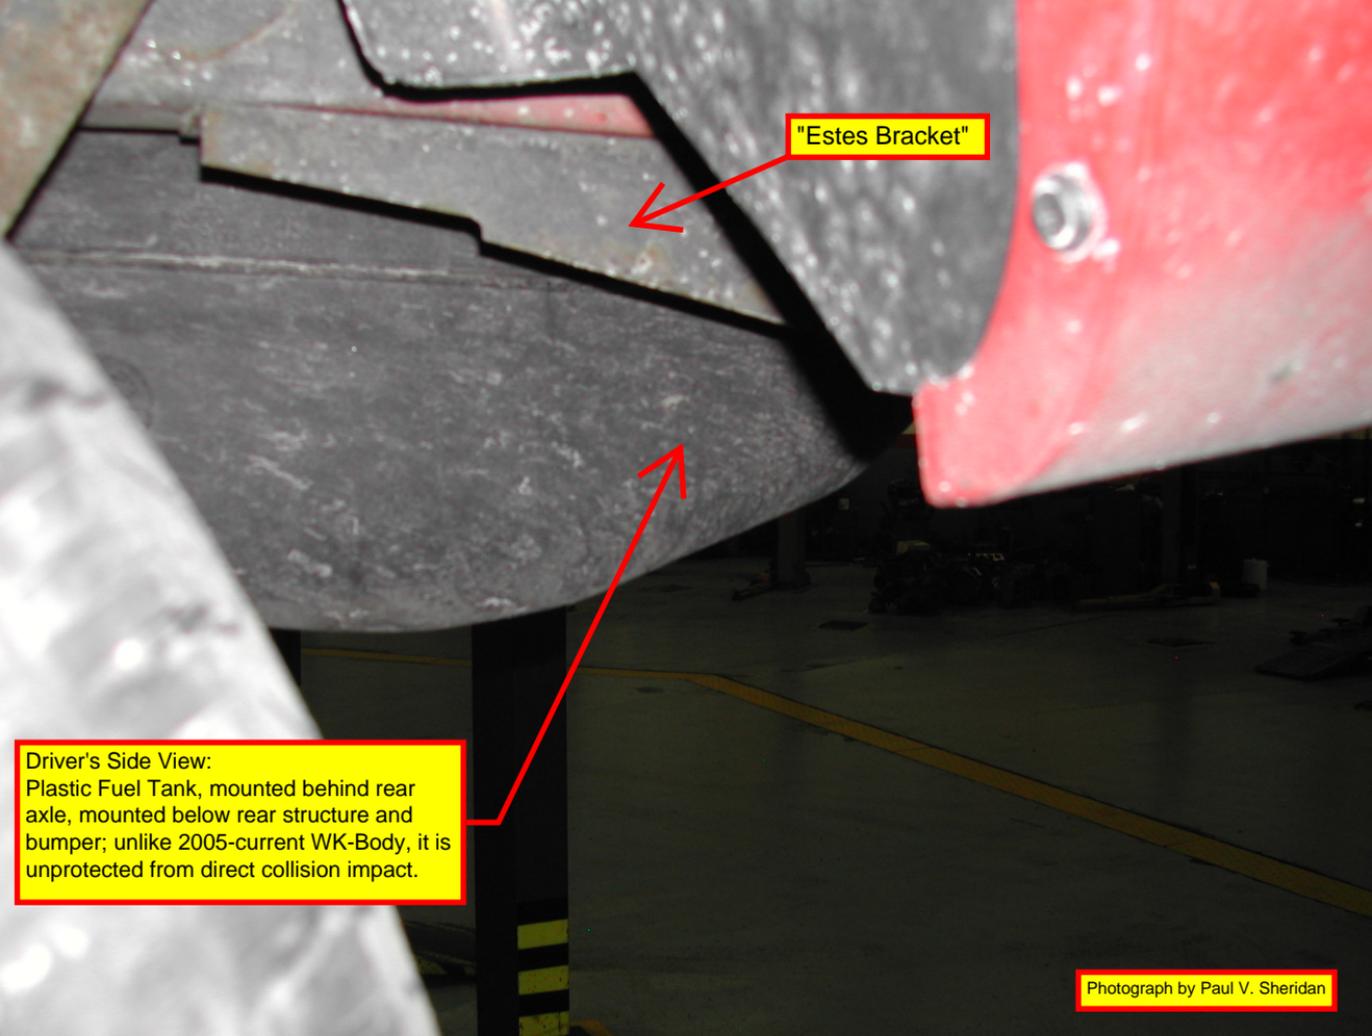
"Estes Bracket"

Driver's Side View:

Plastic Fuel Tank, mounted behind rear axle, mounted below rear structure and bumper; unlike 2005-current WK-Body, it is unprotected from direct collision impact.

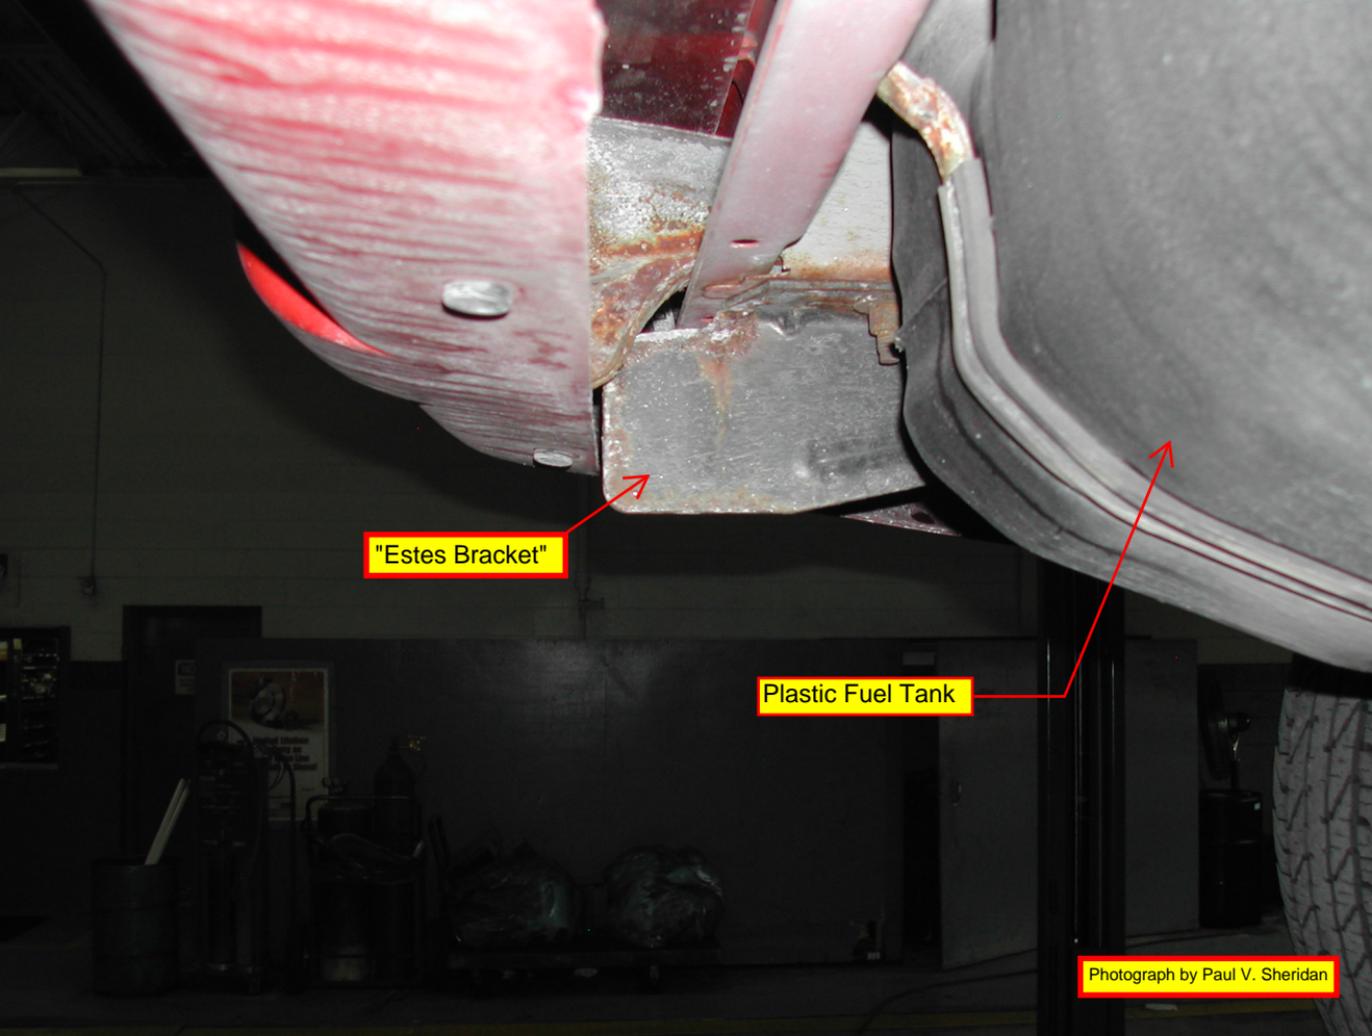
"Estes Bracket"

Plastic Fuel Tank

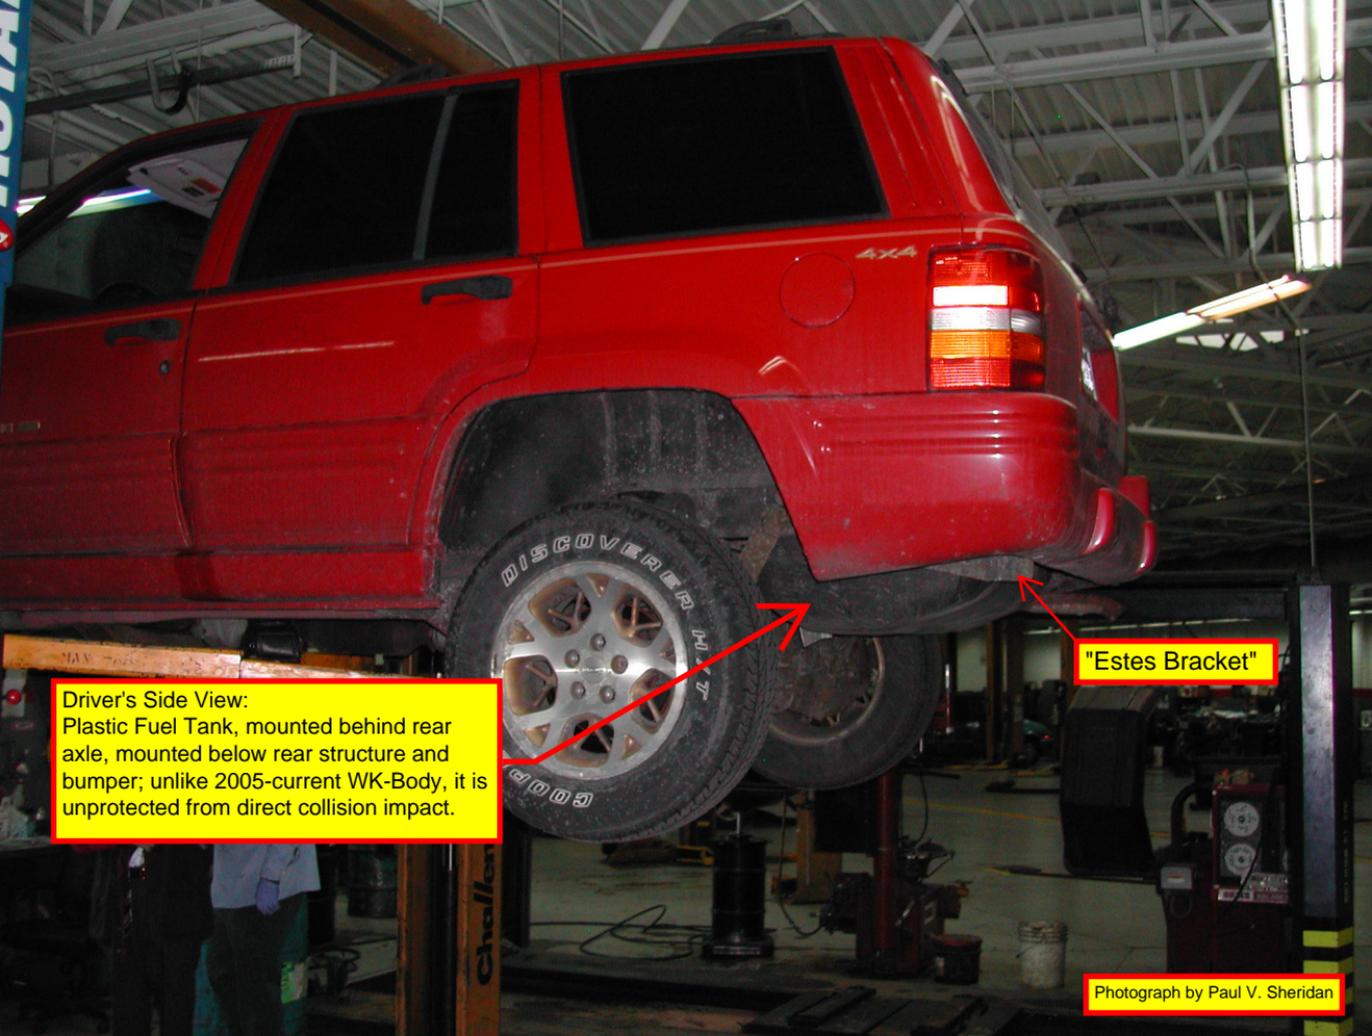
Driver's Side View:

Plastic Fuel Tank, mounted behind rear axle, mounted below rear structure and bumper; unlike 2005-current WK-Body, it is unprotected from direct collision impact.

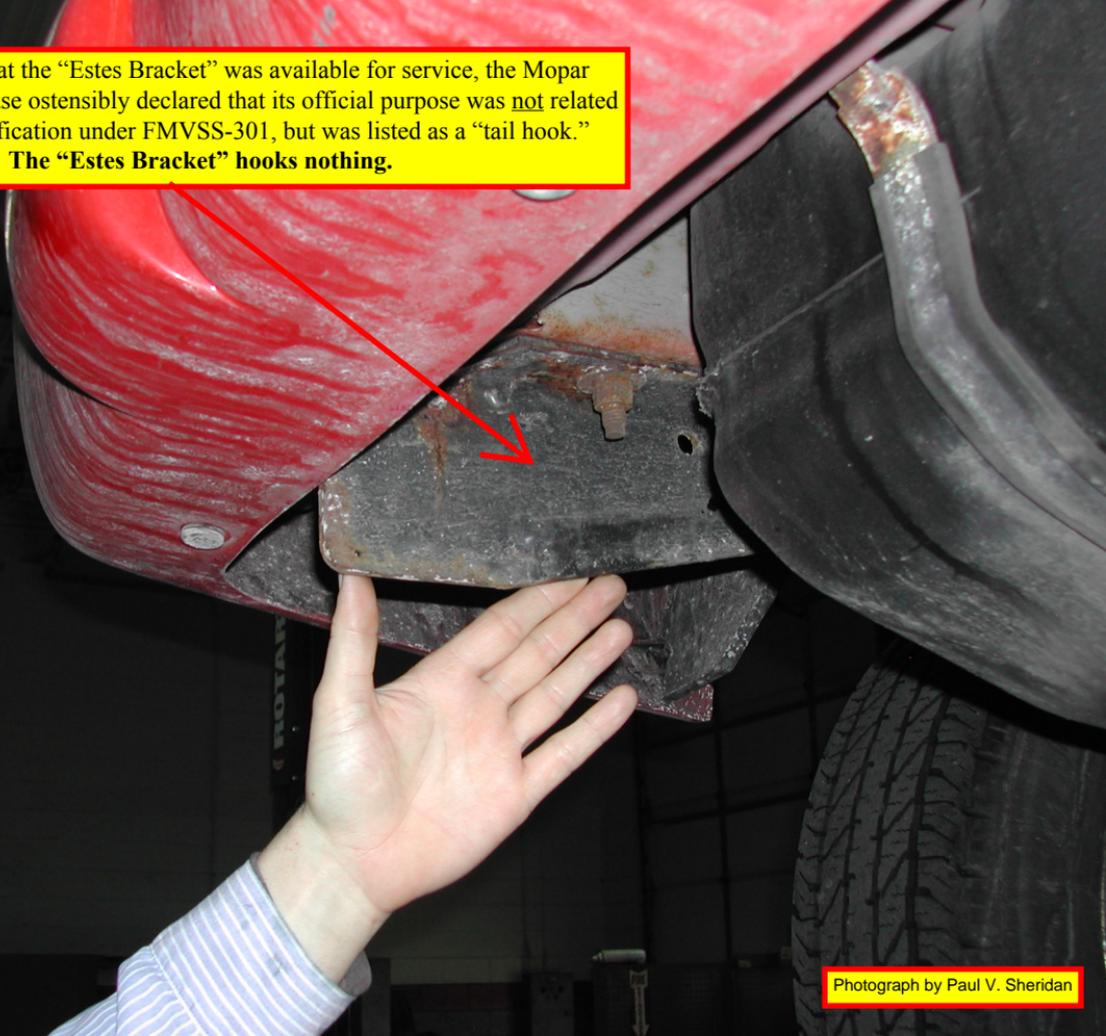
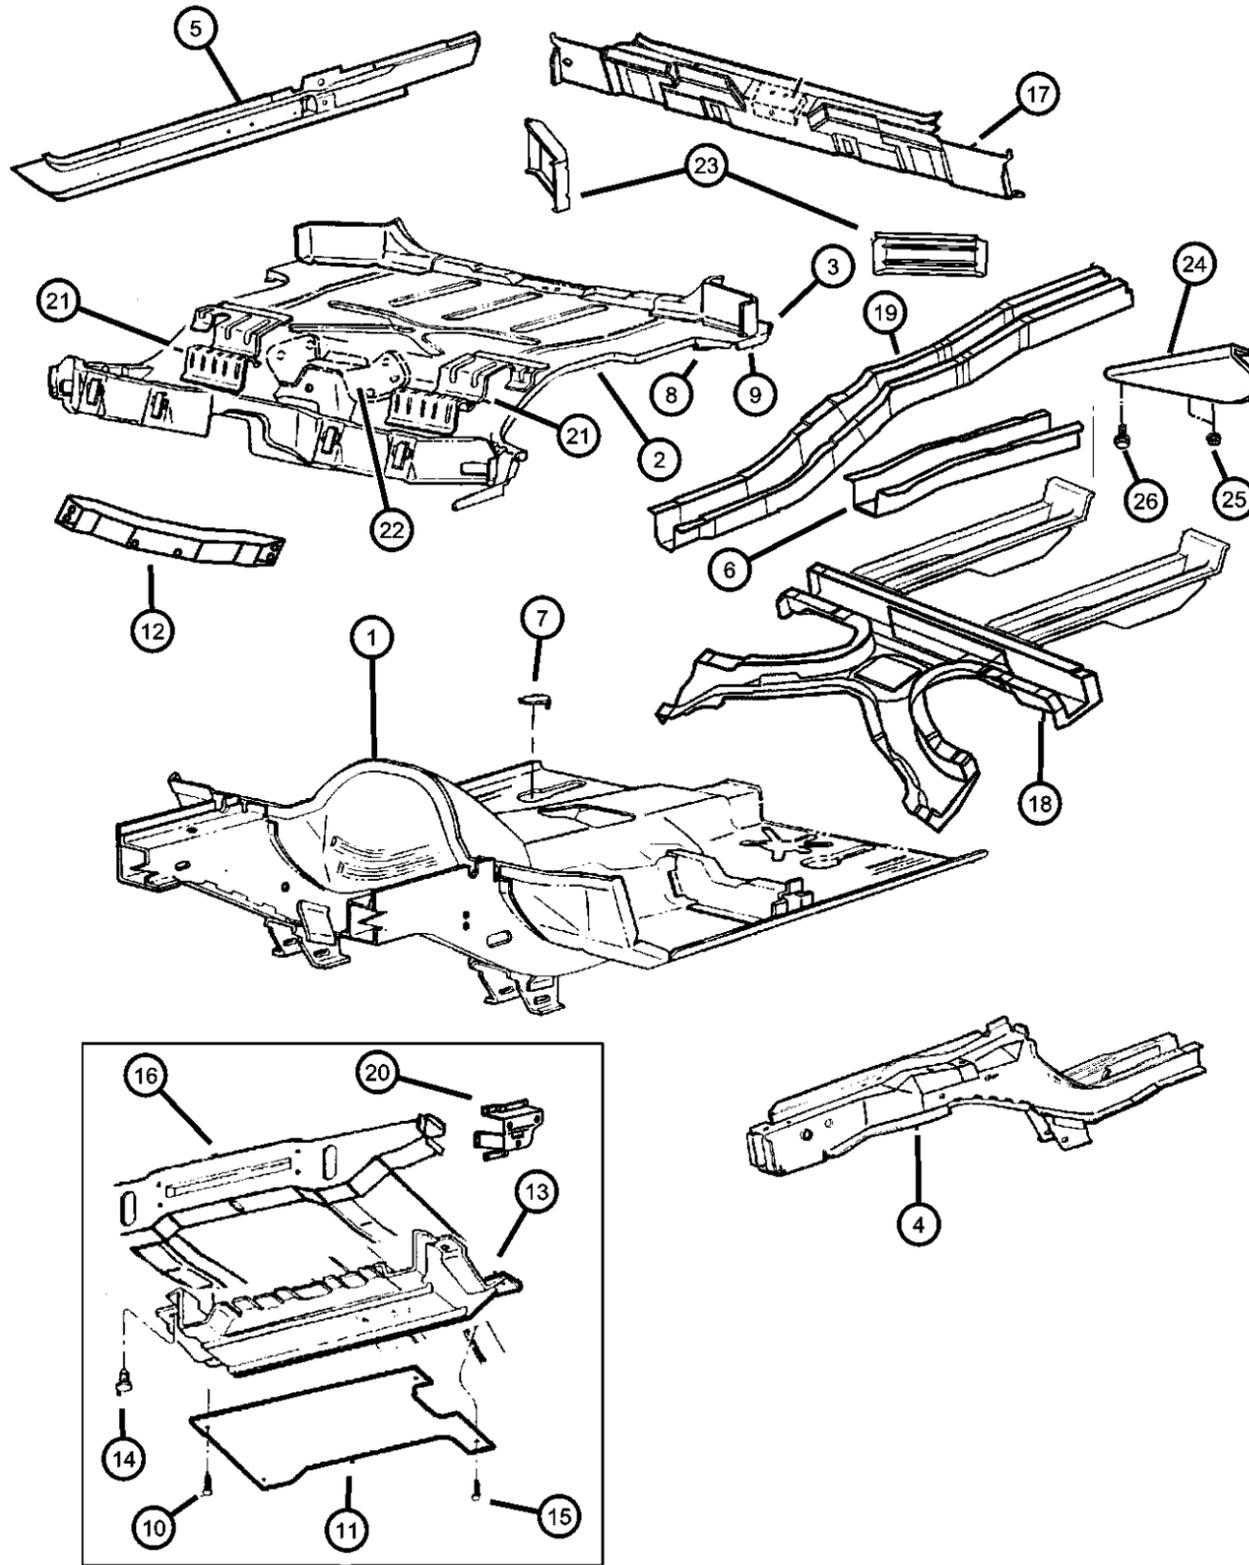
Pans, Floor
Figure SZJ-210

During the time that the “Estes Bracket” was available for service, the Mopar DirectConnect database ostensibly declared that its official purpose was not related to ZJ-Body recertification under FMVSS-301, but was listed as a “tail hook.”

The “Estes Bracket” hooks nothing.

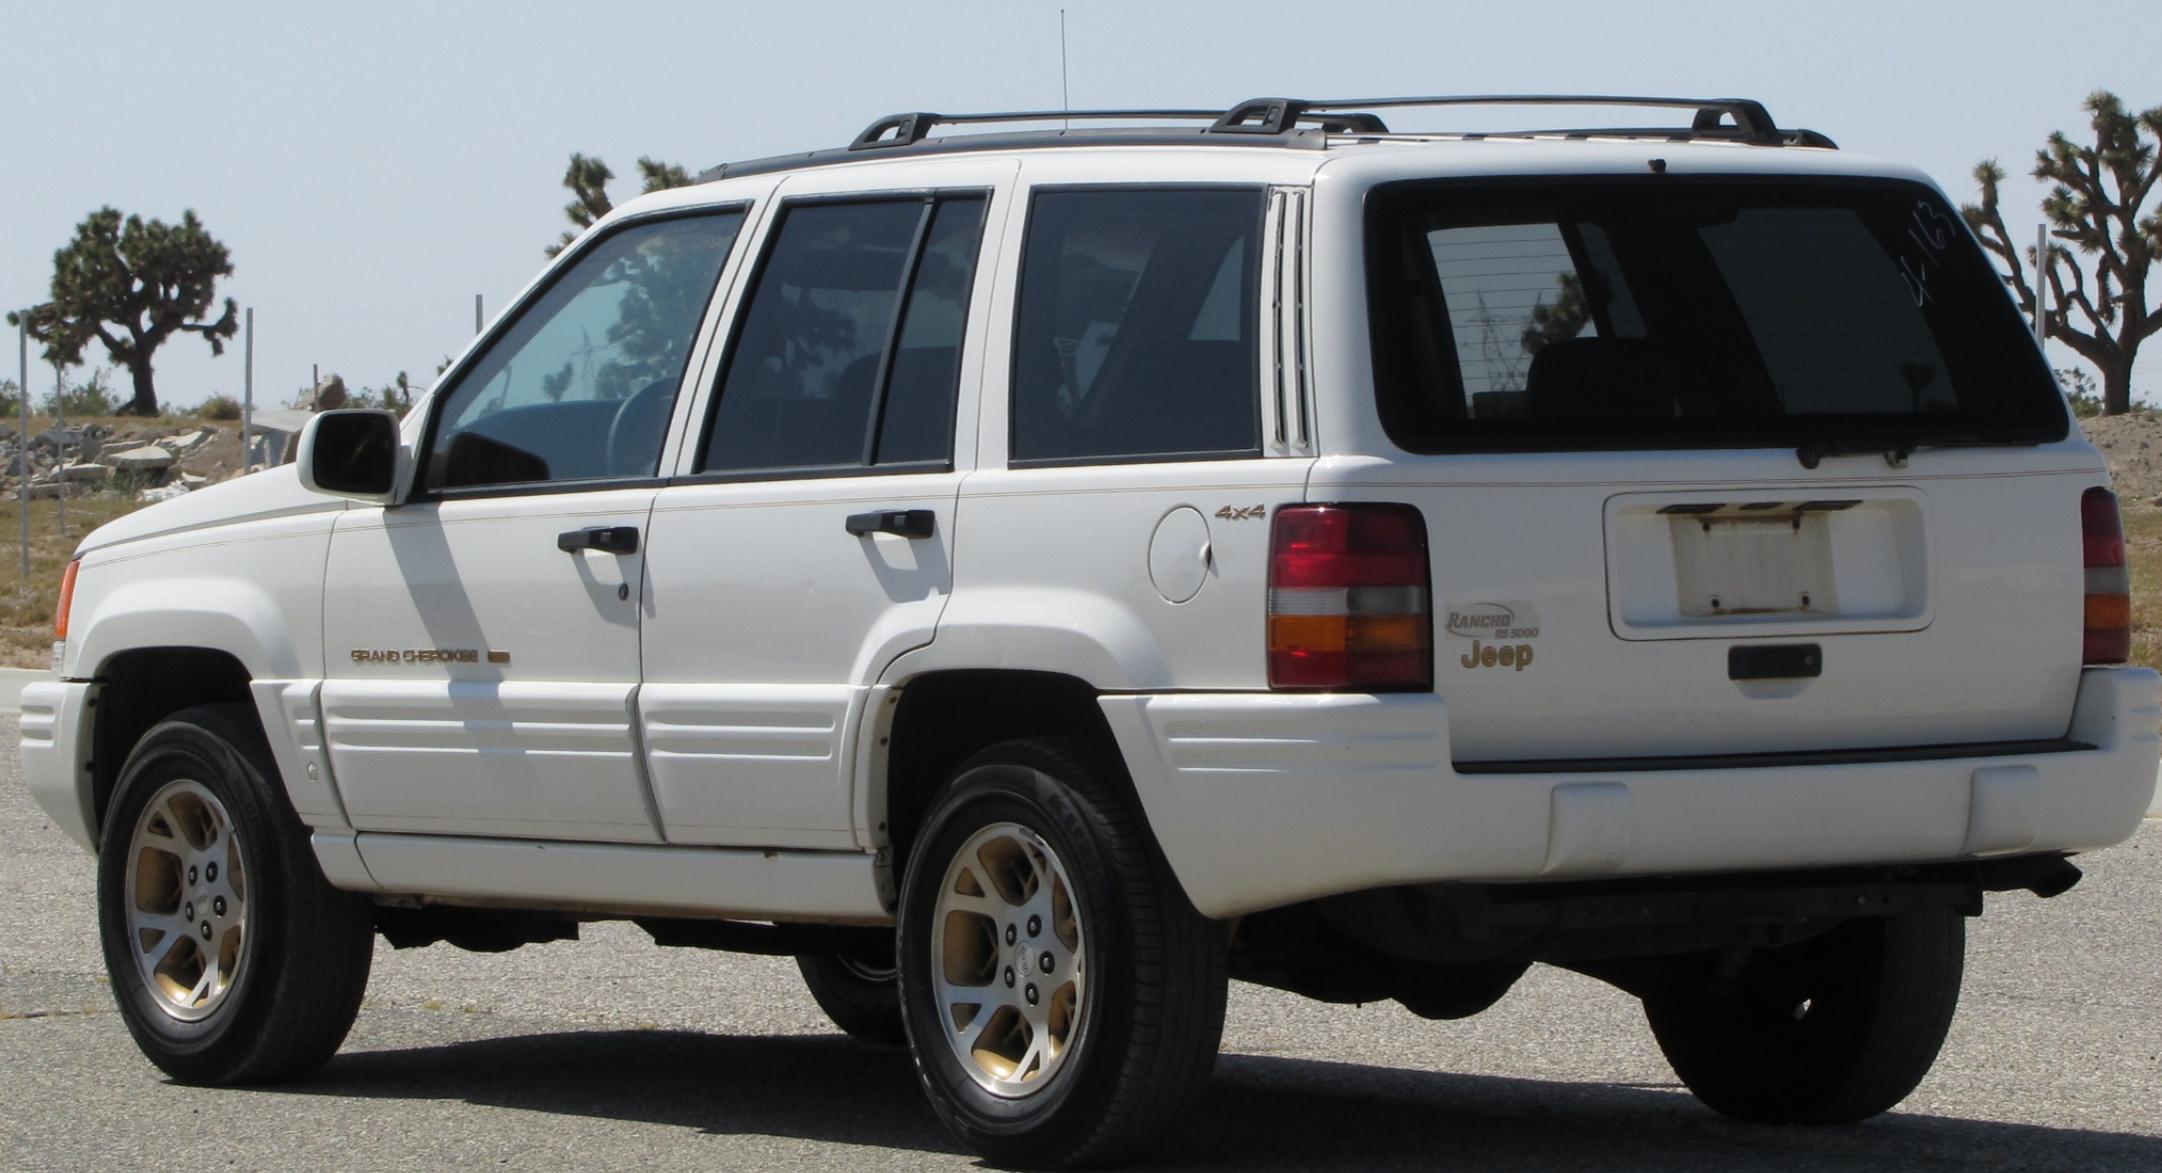
**ZJ-Body Jeep Grand Cherokee:
Typical Customer View (of Fuel Tank)**

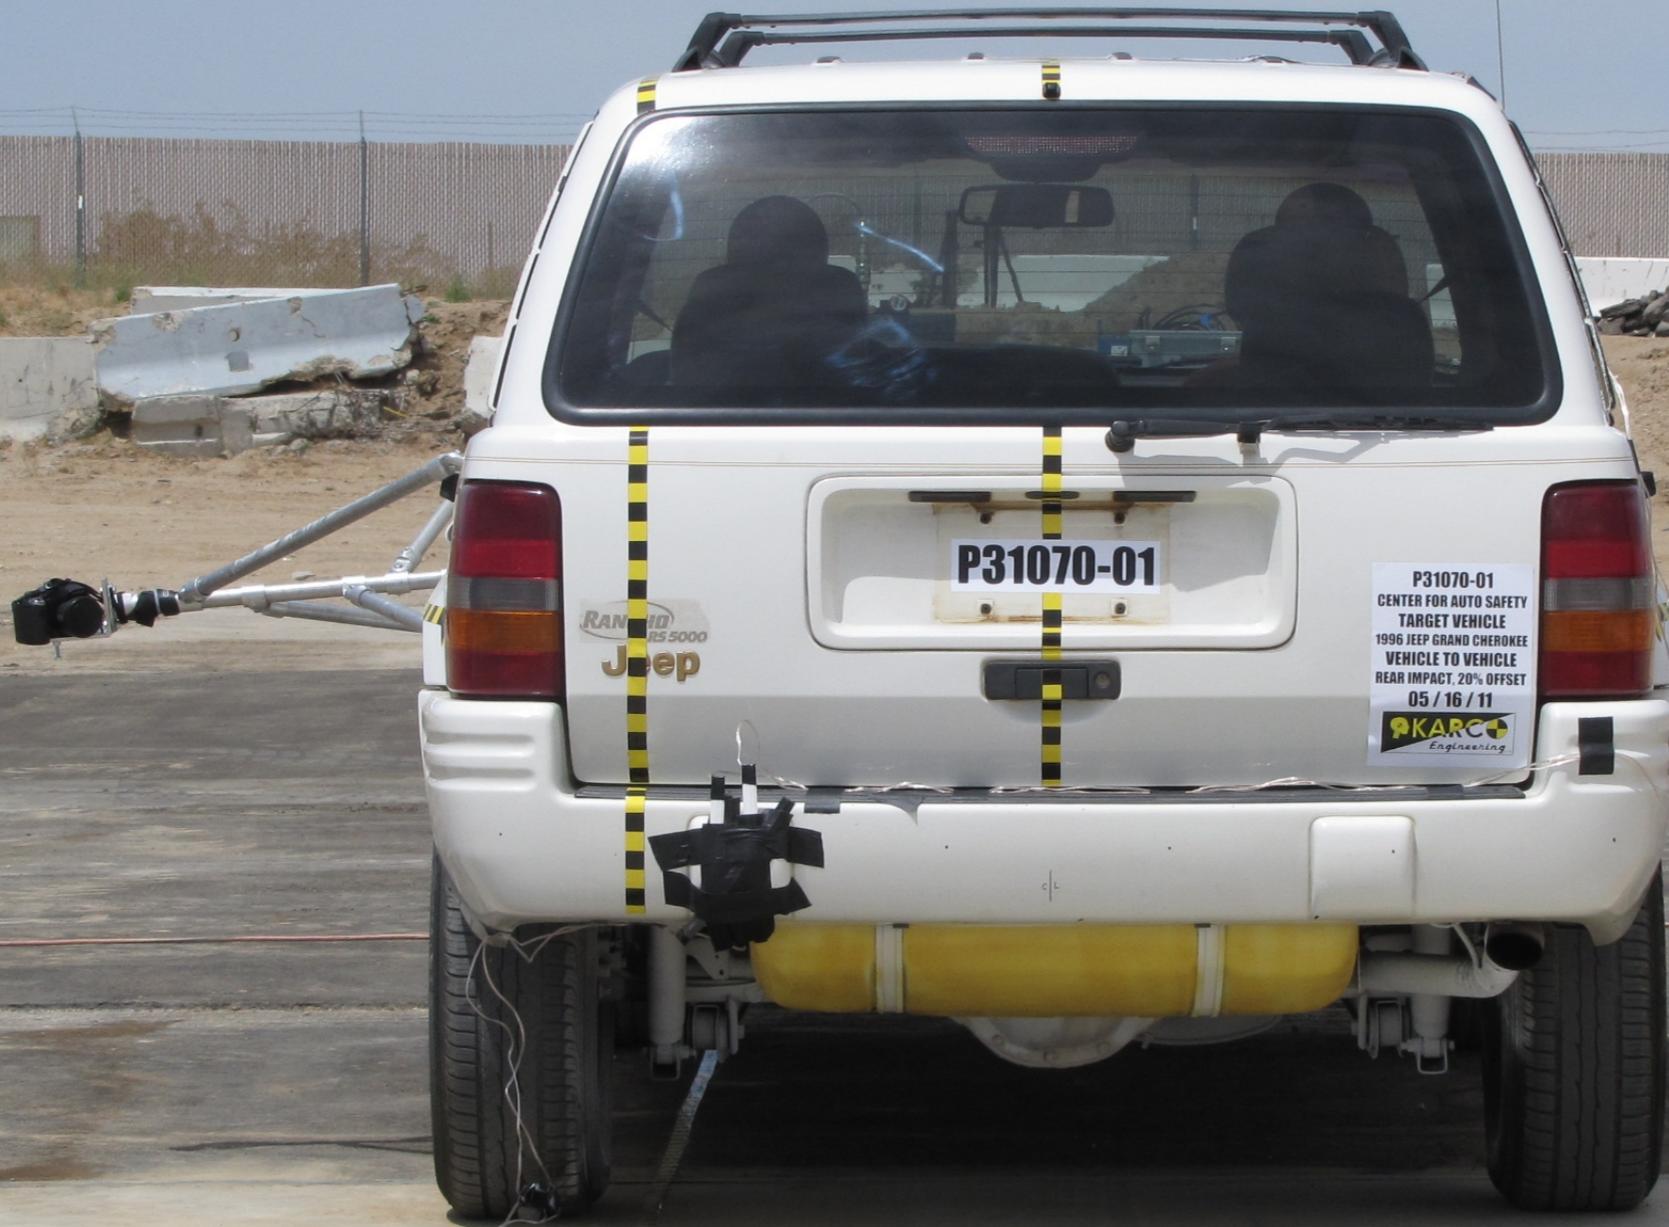
**ZJ-Body Jeep Grand Cherokee:
What Showroom Customer Would See if
Fuel Tank was not color-matched to rear
underbody / rear suspension components.**

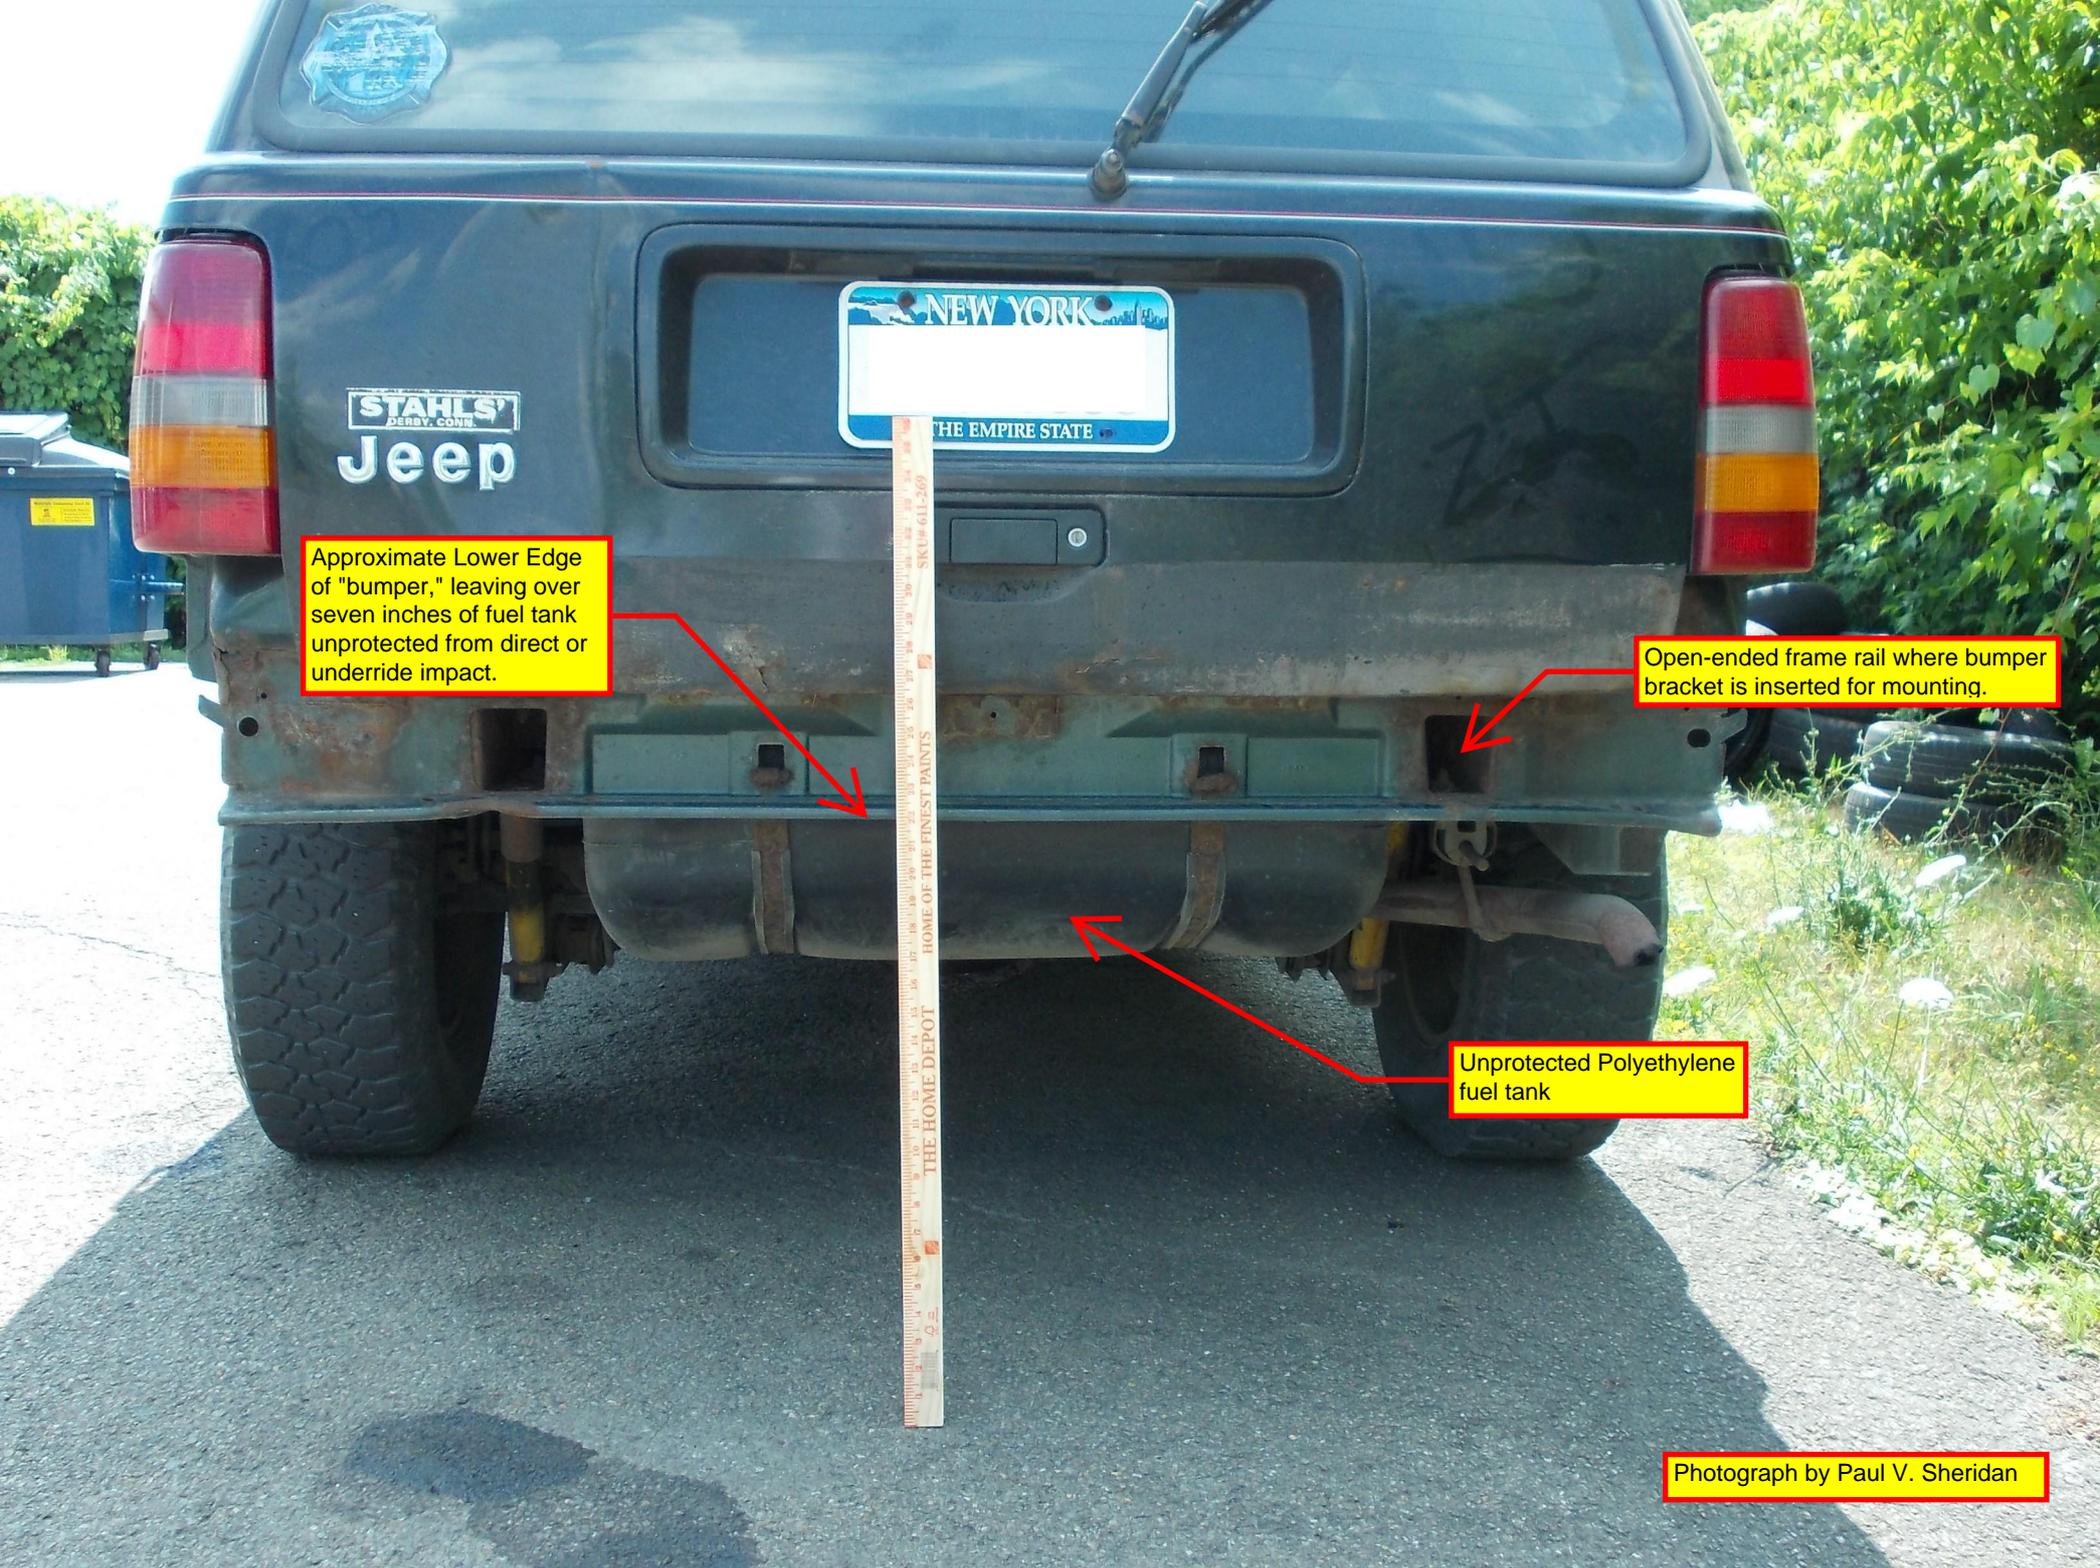
Approximate Lower Edge of "bumper," leaving over seven inches of fuel tank unprotected from direct or underride impact.

Open-ended frame rail where bumper bracket is inserted for mounting.

Unprotected Polyethylene fuel tank

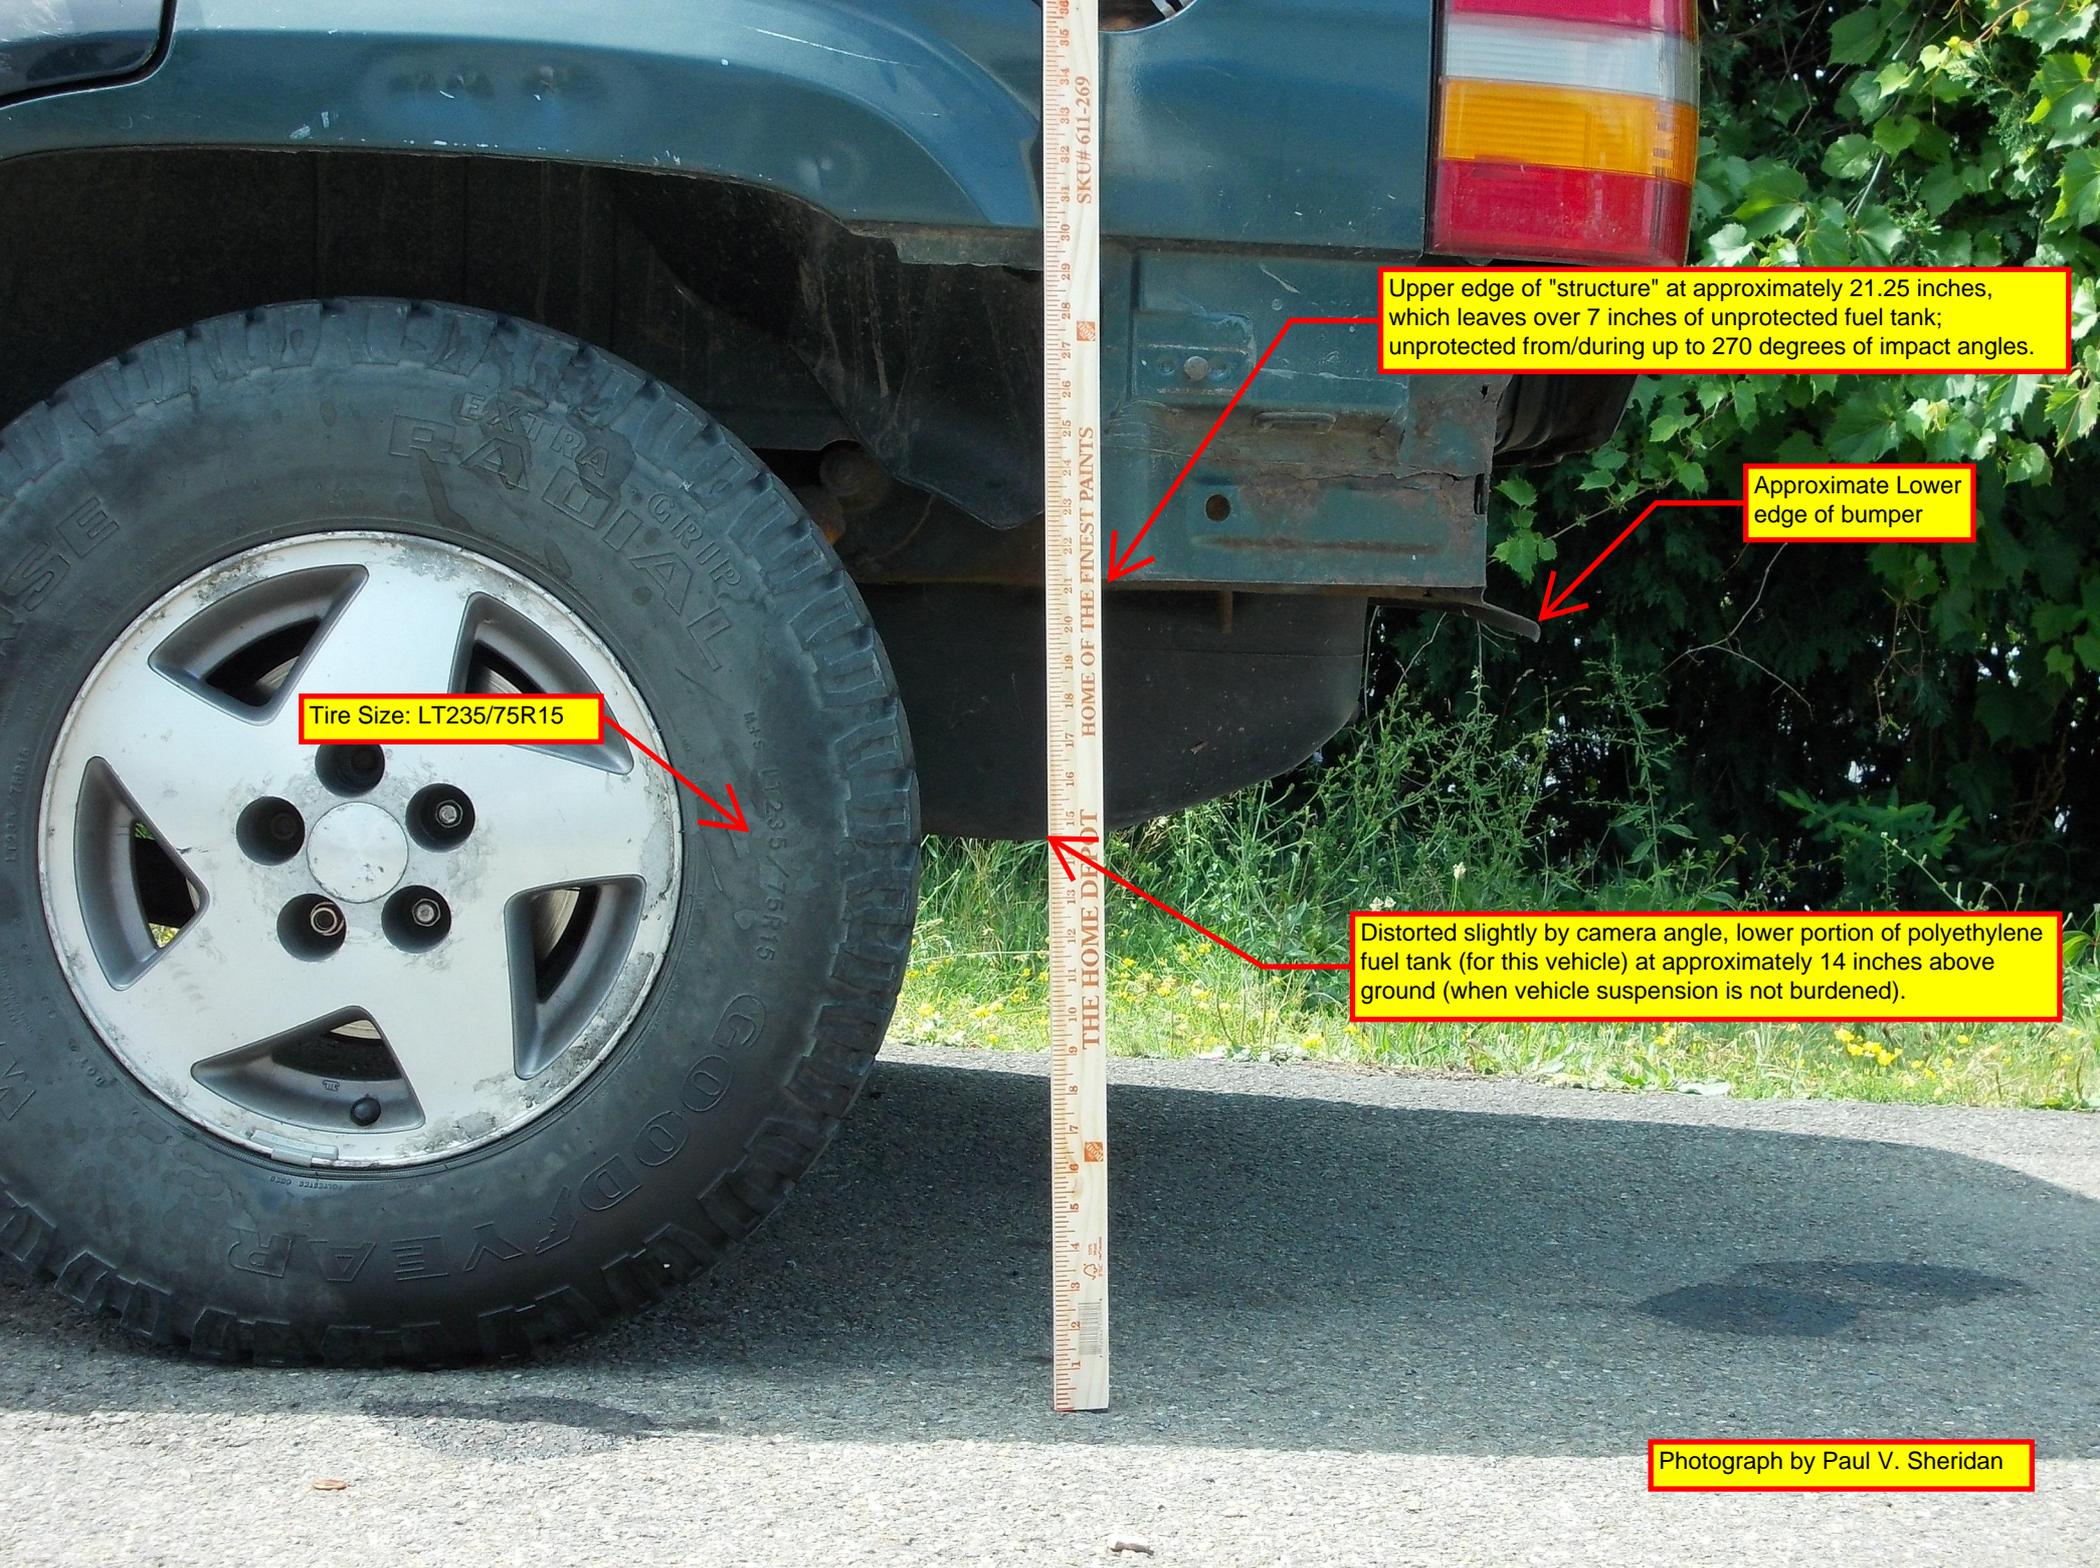
Tire Size: LT235/75R15

Upper edge of "structure" at approximately 21.25 inches, which leaves over 7 inches of unprotected fuel tank; unprotected from/during up to 270 degrees of impact angles.
