Subject: Chrysler Group, LLC Failure-to-Warn/Comply under 49 CFR § 573.6, et al.

Reference 1: Toyota Motor Corporation/NHTSA Recall 12V-305
Reference 2: EA12-005 File Update (Chrysler Jeep Fuel Tank System Safety Defect)

Chrysler Jeep Fuel System Defect Investigation EA12-005

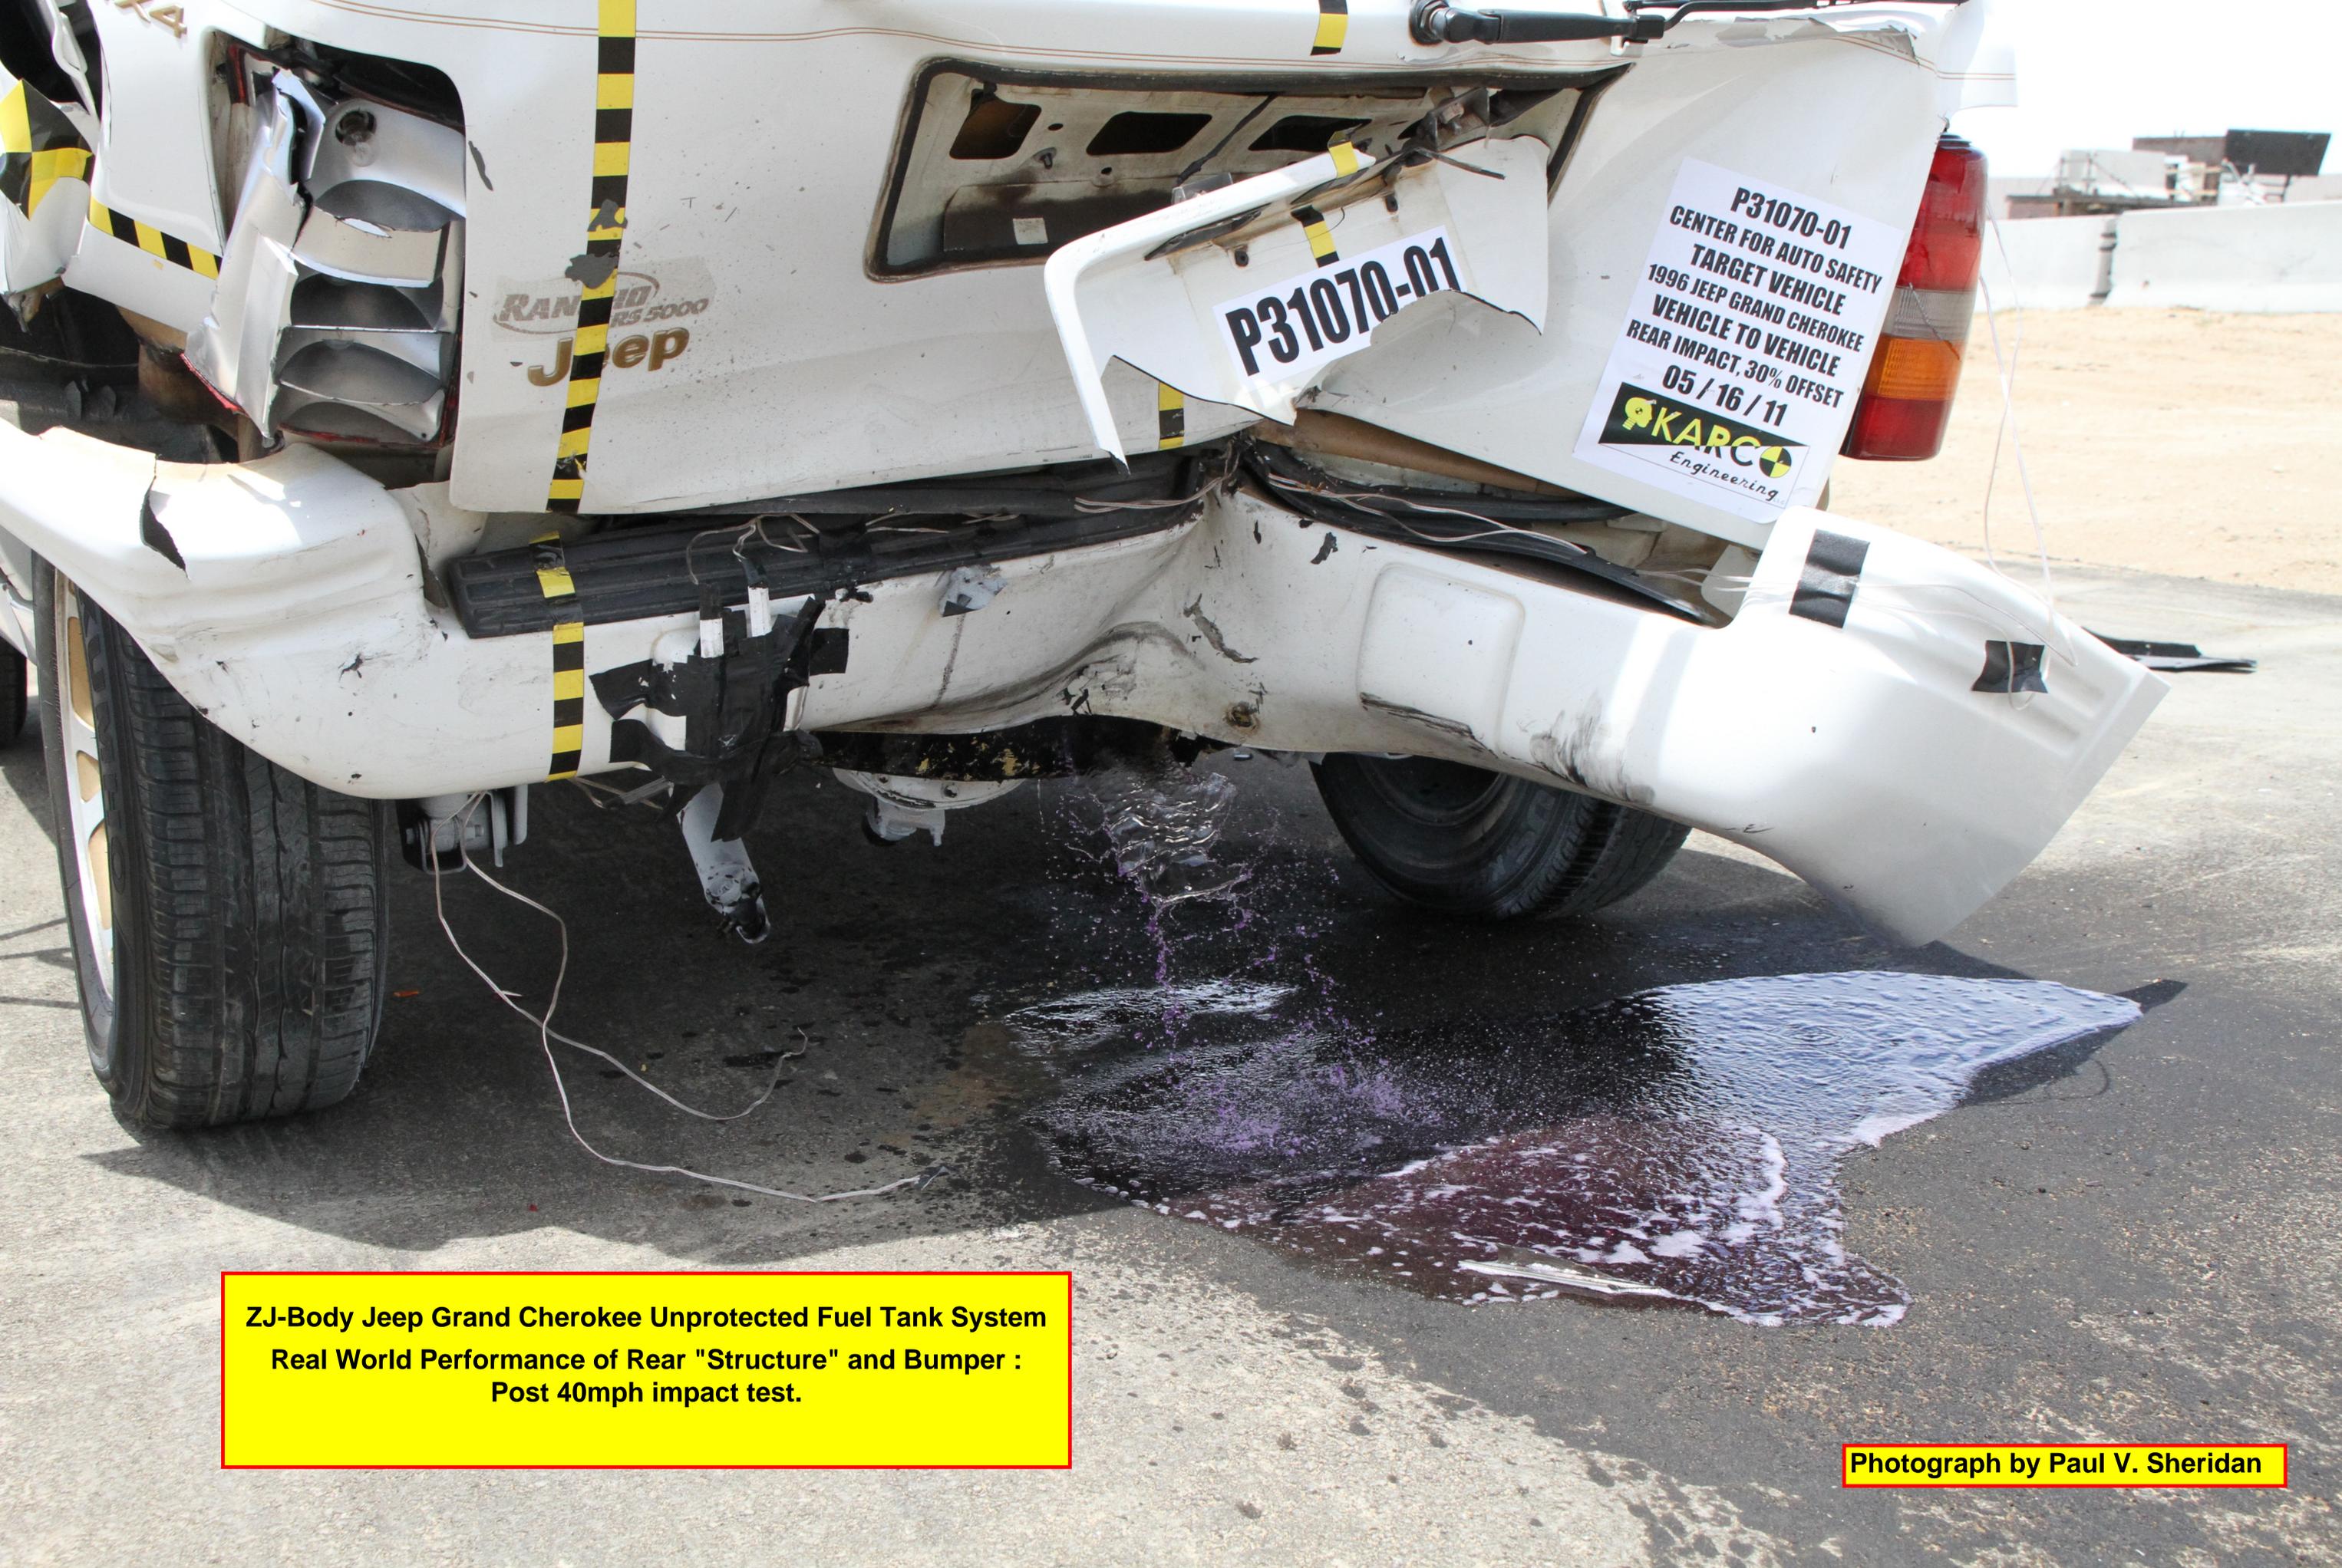
**ZJ-Body Jeep Grand Cherokee Unprotected Fuel Tank System
Real World Performance of Rear "Structure" and Bumper :
Post 40mph impact test.**
