Subject: Chrysler Group, LLC Failure-to-Warn/Comply under 49 CFR § 573.6, et al.

Reference 1: Toyota Motor Corporation/NHTSA Recall 12V-305
Reference 2: EA12-005 File Update (Chrysler Jeep Fuel Tank System Safety Defect)

Chrysler Jeep Fuel System Defect Investigation EA12-005

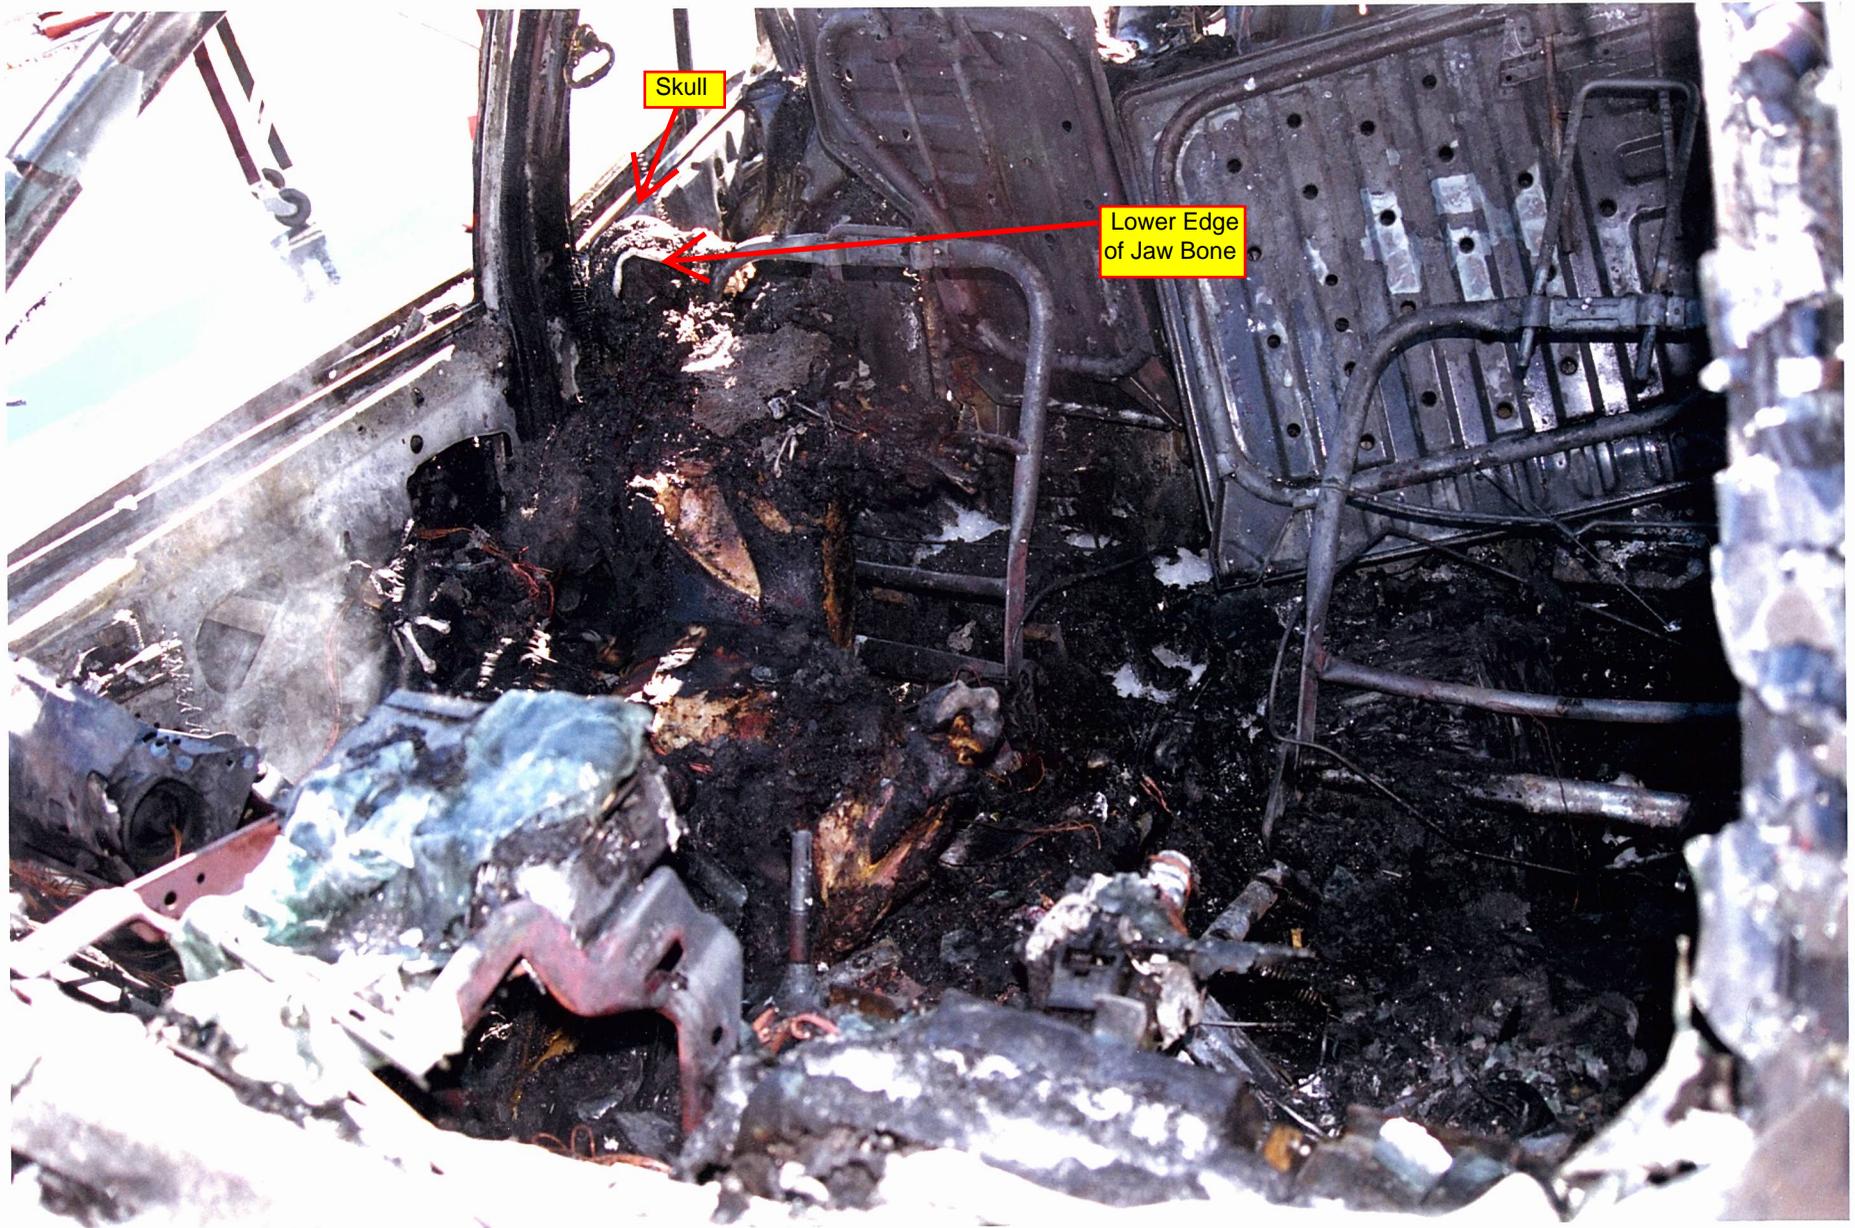
Skull

Lower Edge
of Jaw Bone

Mrs. Susan Kline (death victim):
Post fuel fed fire-death caused by defective fuel system/
tank design in Jeep Grand Cherokee SUVs

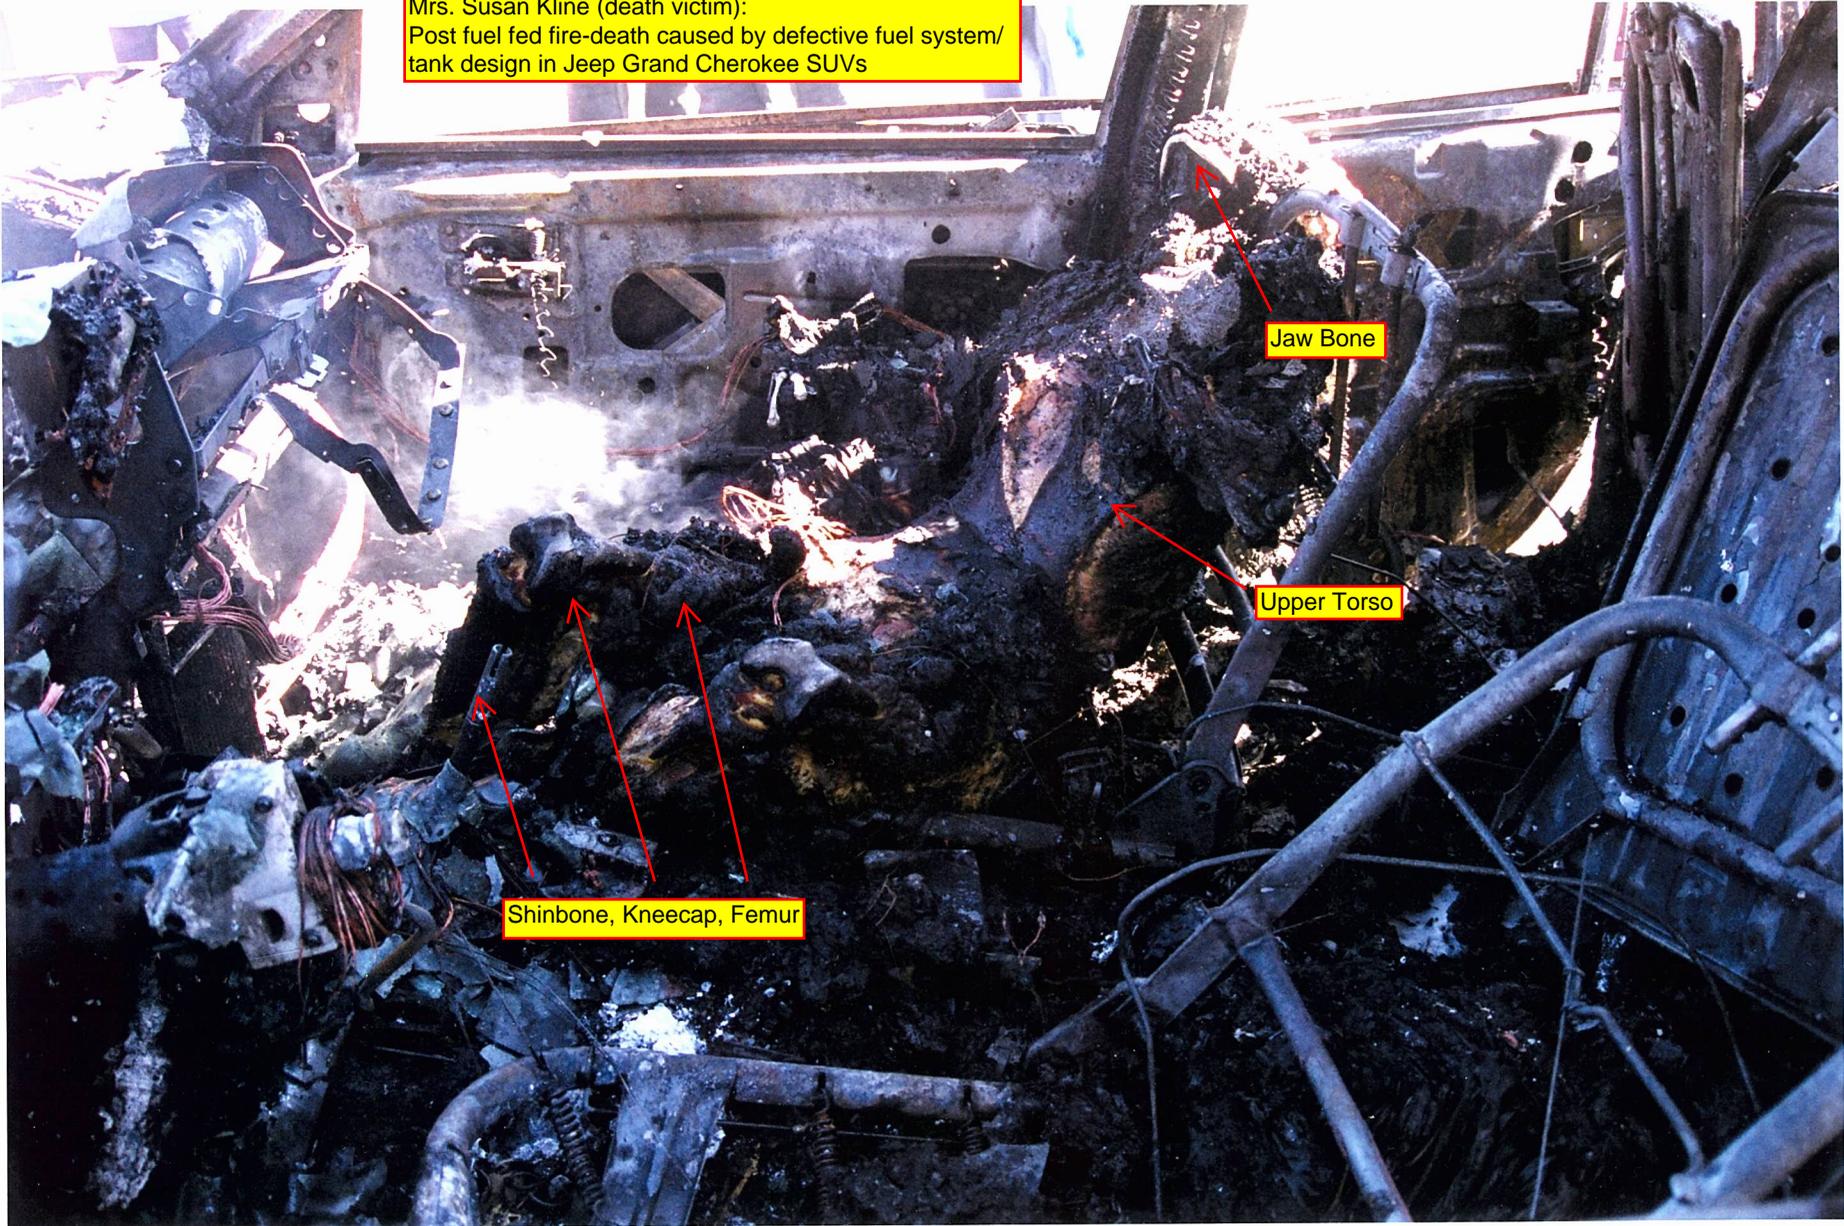
Jaw Bone

Upper Torso
