CENTER FOR AUTO SAFETY

PETITION

The Center for Auto Safety (CAS) petitions the National Highway Traffic Safety Administration (NHTSA) to initiate a defect investigation into and recall all 1993-2004 Jeep Grand Cherokee with a fuel tank located behind the rear axle. Unlike the earlier Jeep Cherokee, the fuel tank of the Grand Cherokee is plastic and extends below the rear bumper so there is nothing to protect the tank from a direct hit in a rollover or by a vehicle with a low front profile or one lowered by pre-impact braking.

ALLEGED FUEL TANK AND FILLER NECK DAMAGE IN REAR-END
COLLISION OF SUBCOMPACT PASSENGER CARS

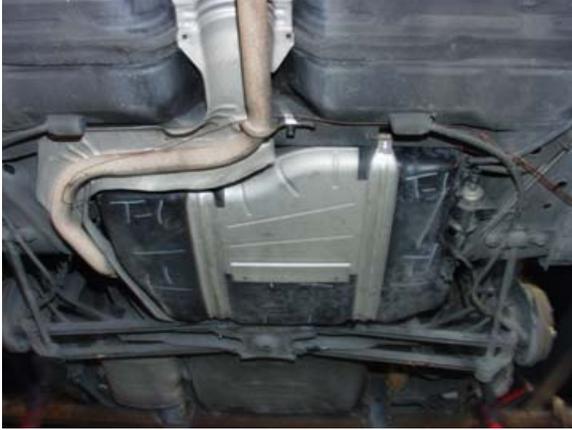
Figure 11. "Pancake" shaped tank pre-test.

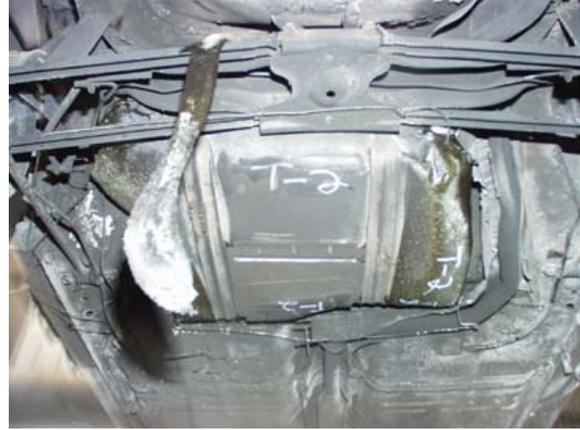
Figure 14. "Pancake" tank after fire test.

leakage was observed, the fire was extinguished quickly by fire suppressants. The results reported in Table 3 shows the number of seconds after removal of the screen at 2 minutes until the tank leakage occurred

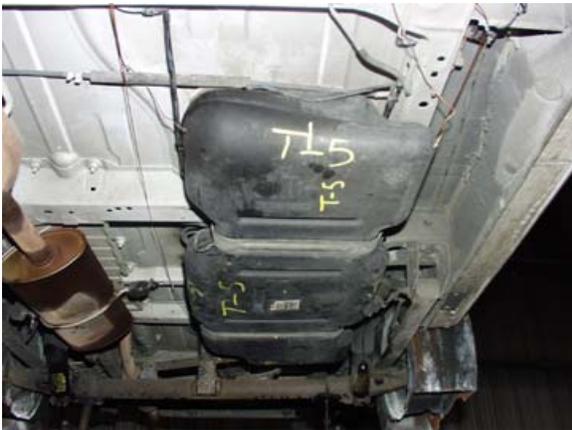
Figure 12. "Long" shaped tank pre-test.

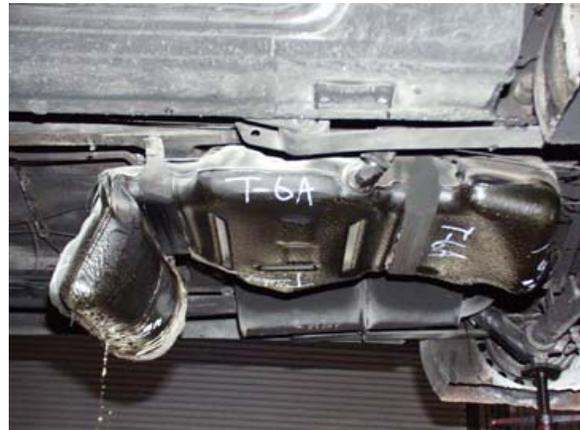
Figure 15. "Long" tank after fire test.

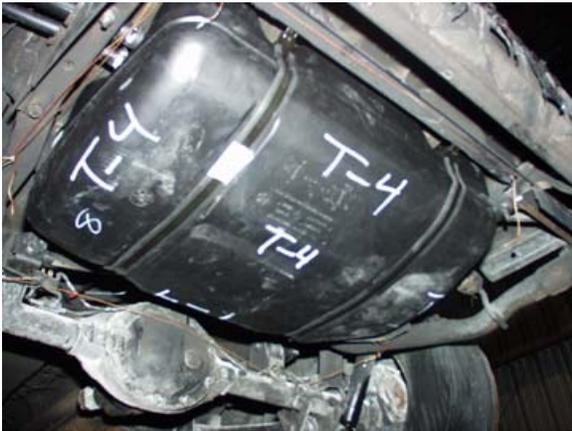
Figure 13. "Square" shaped tank pre-test.

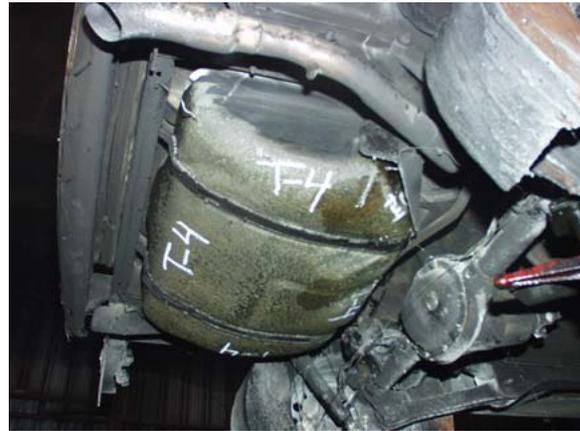
Figure 16. "Square" tank after fire test.

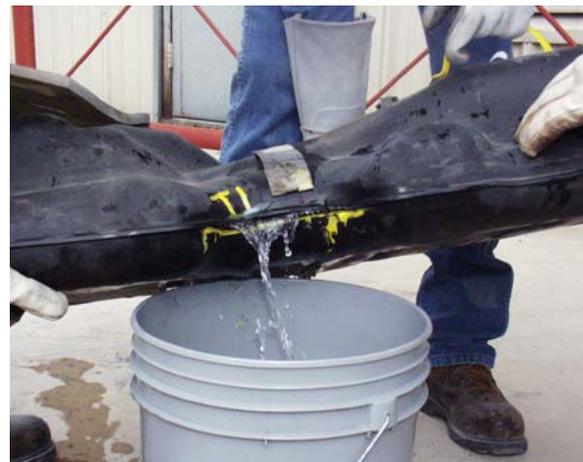
Figure 17. Seasoned “Long” Tank Post Drop Test

The results of the 30 ft drop tests are shown in Table 4. All of the new tanks and the seasoned pancake tank passed the test. However, both of the other seasoned tanks ruptured at the pinch-off separation. A typical breach of the tank is shown in Figure 17.
